## Problems observed with MIRA-1000 type magnetic tapes

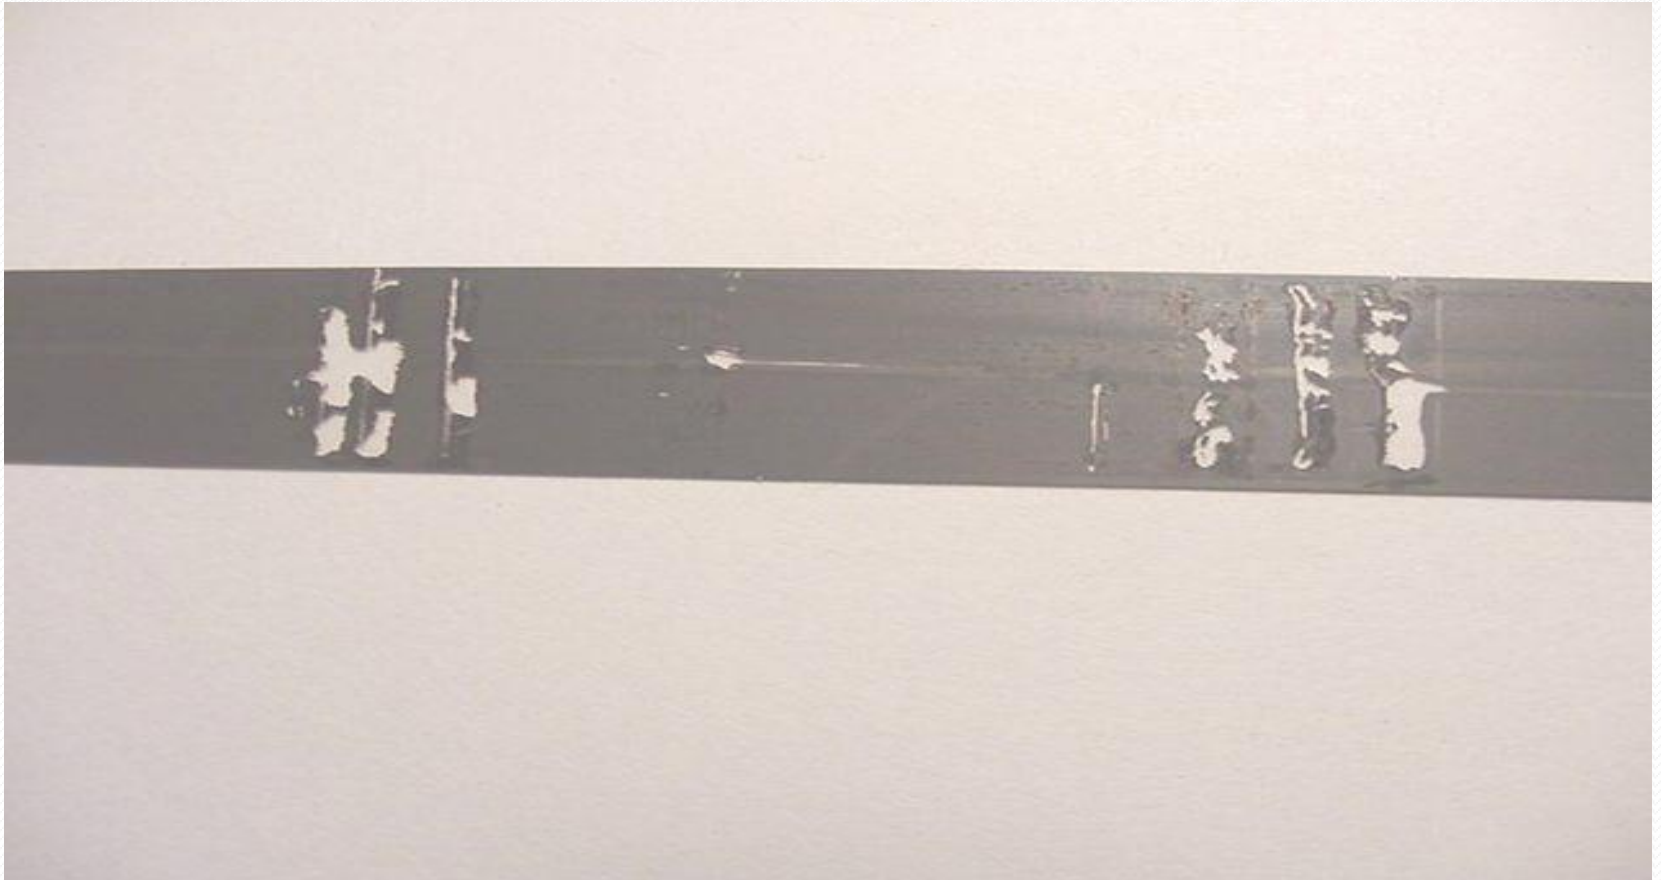
- Severe stiction causing frequent tape drive faults.
- Material deposits on a drive head and/or tape cleaner, sometimes removable.
- Holes occurred in the tapes because of coating pullout.
- Stretched and wrinkled tape resulting from the tape having stuck previously in a tape drive.

## Severe Stiction effect, tapes peeled from Magnetic Heads

- In contact with water, Polyurethane binder undergoes hydrolysis, higher temperatures accelerate the reaction
- Lower molecular weight polymers formed, cause the tape coatings to become sticky
- Polyurethane hydrolysis can be temporarily partially reversed by heating a tape at a relatively low temperature for several days.

- Use certified media to archive electronic information.
- Allow for incoming media to acclimatize for a minimum of 24 hours before attempting to process.
- Archive tapes in controlled environment. Temp 66-68 F and 30-35% humidity.
- Rewind/retention all media types.
- Migrate E-records from legacy media formats to newer formats.

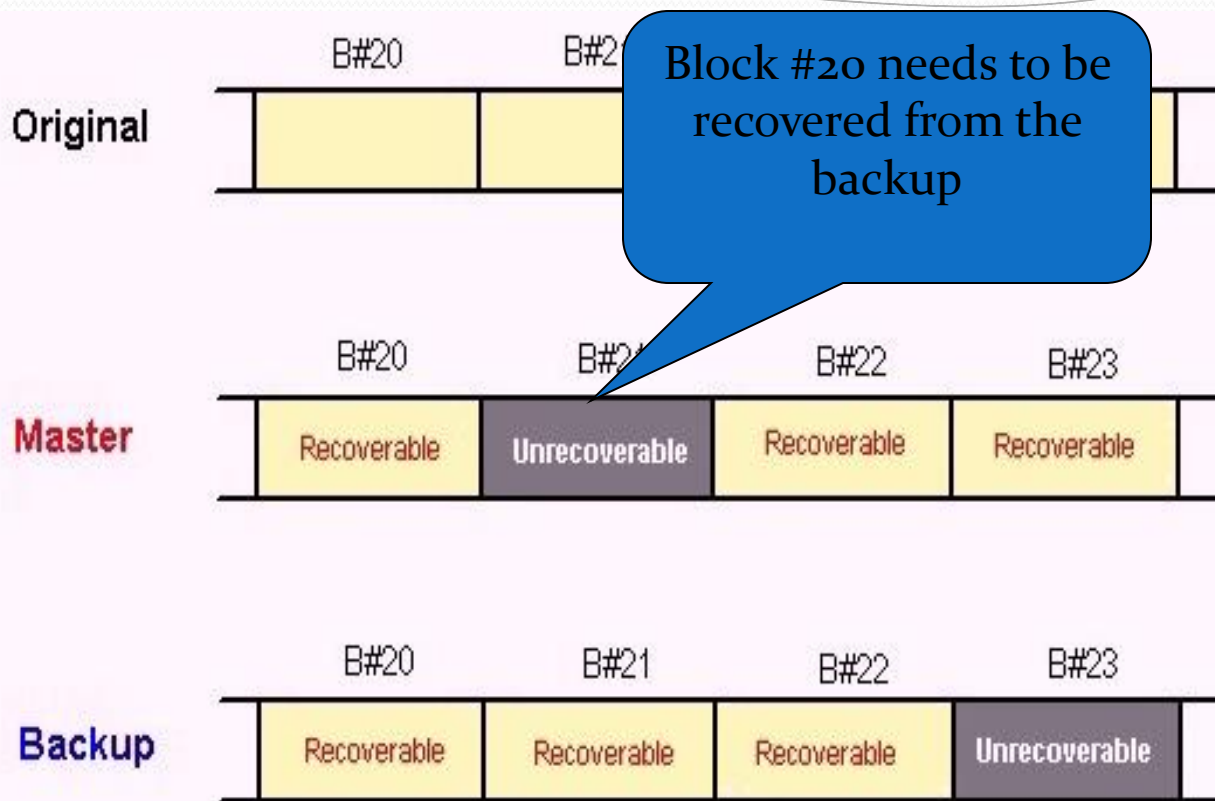
Merge **Master** and **Backup** to get complete blocks of data for Block# (20-23)
